**NASA CONTRACTOR
REPORT**

**(CAVITATION DAMAGE OF MECHANICAL
PUMP IMPELLERS OPERATING IN
LIQUID METAL SPACE POWER LOOPS)**

by R. S. Kulp and J. V. Altieri

Prepared under Contract No. NAS 3-2541 by
PRATT & WHITNEY AIRCRAFT DIVISION
UNITED AIRCRAFT CORPORATION
Middletown, Conn.

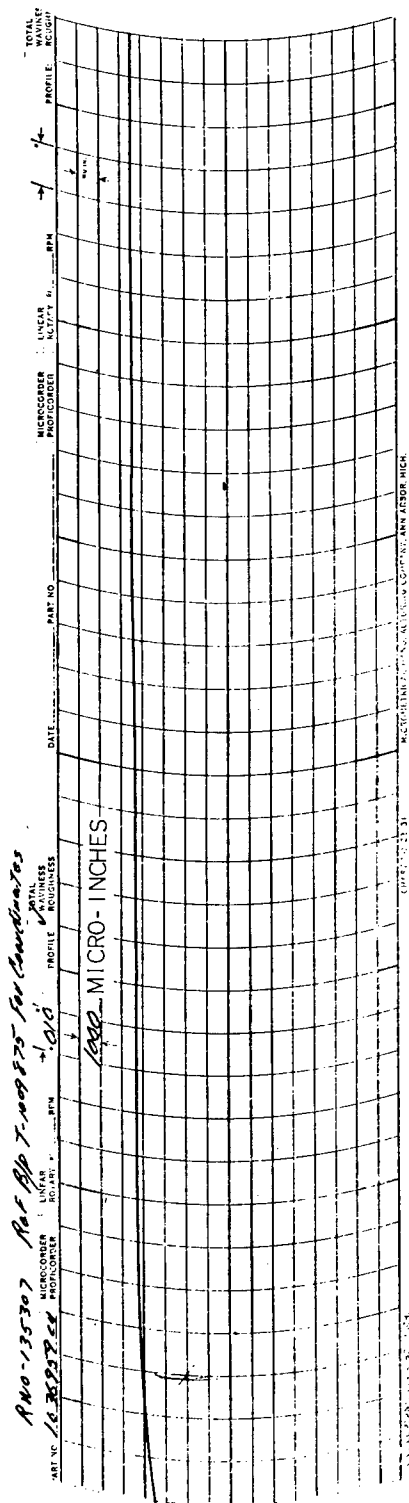
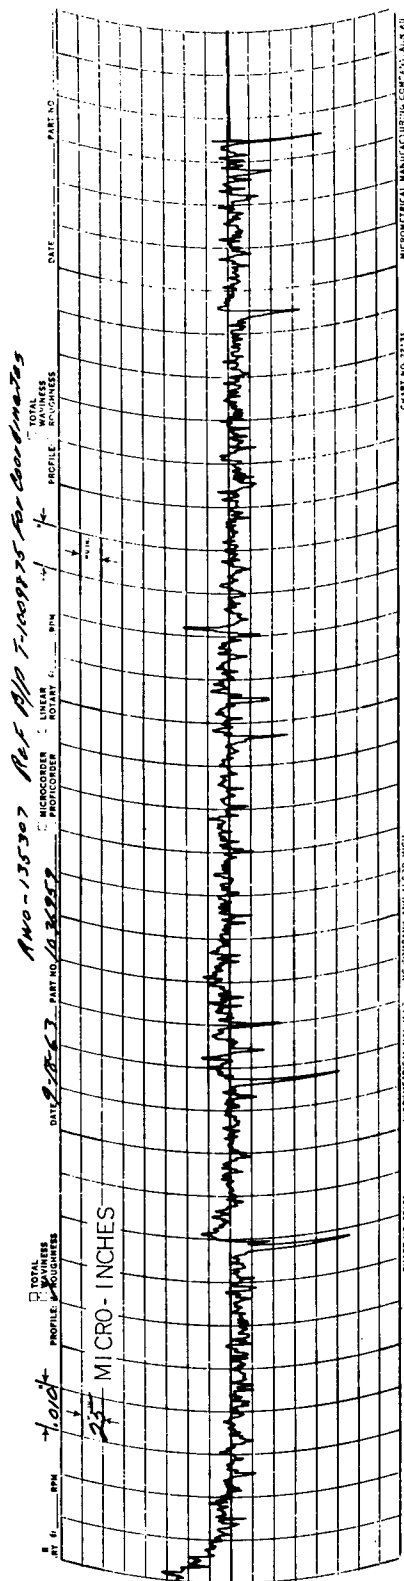
FIG 5

at the root of blade 3 indicated by the previous inspection (Fig. 5). Photographs of the inlet suction surfaces were again made at magnifications of two and four times size. Rubber molds of the entire impeller surface were made using the silicon rubber compound.

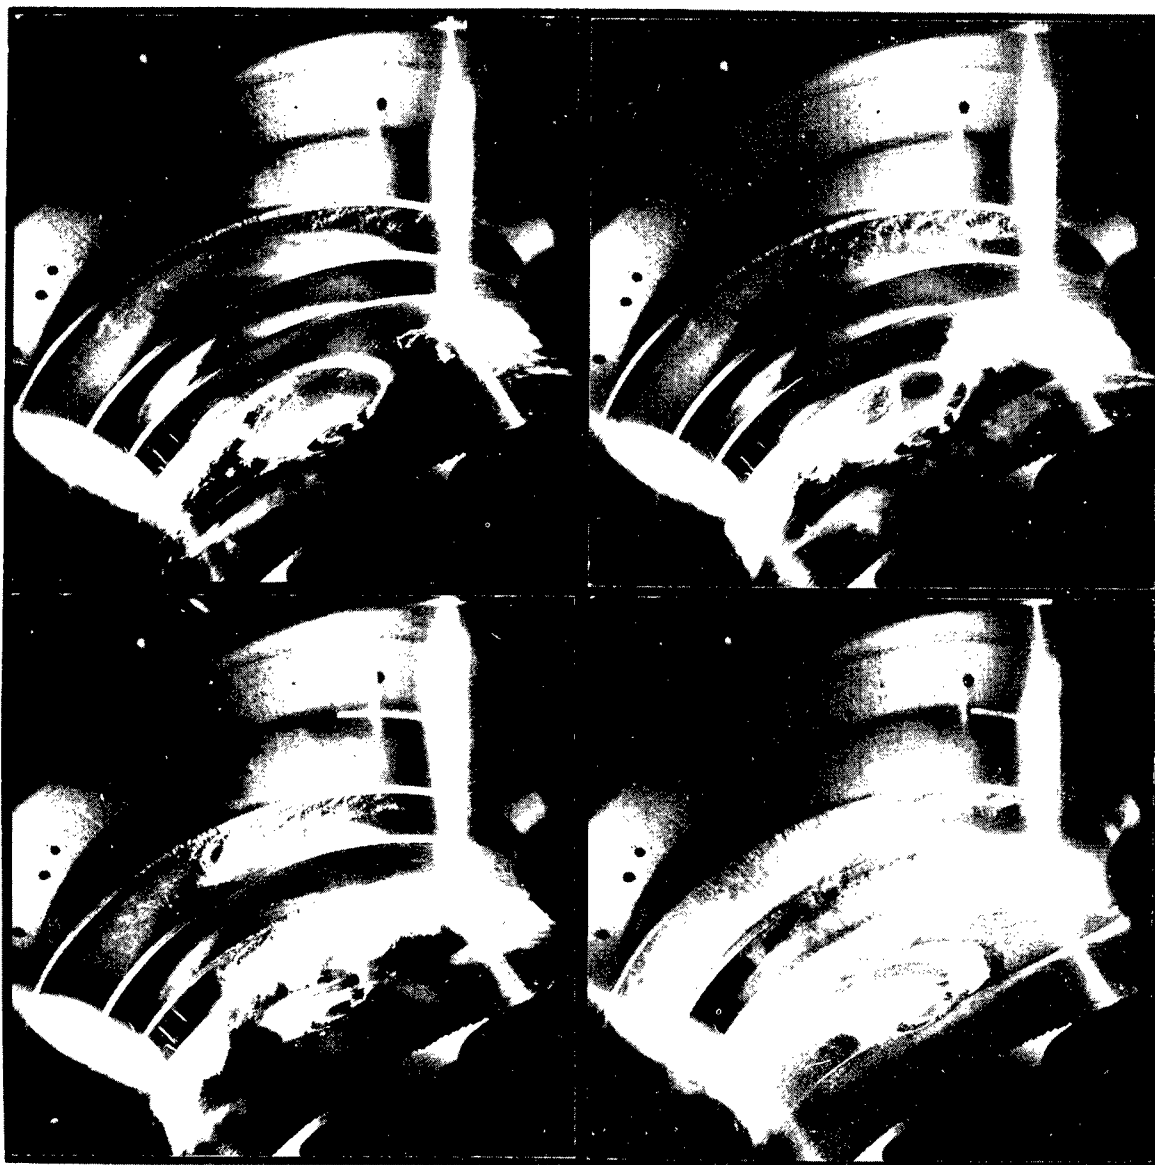
FIG 26

Some of the still photographs taken during this test series are shown in Figs. 26, 27, 28, 29 and 30 for the flows of 660, 680, 700, 720 and 740 gpm, respectively. These photographs clearly show the cavitation patterns on the impeller as a function of NPSH. Fig. 28 shows that cavitation exists on the impeller to NPSH values of 150 feet at a shaft speed of 6375 rpm. Photographs were taken using a 35 mm camera with a 55 mm lens at NPSH values of 150, 100, 60, 35, incipient head loss, 15 and 8 feet for each of the five flows. The incipient head loss point is that point just before a drop in pump head rise is observable as NPSH is decreased.

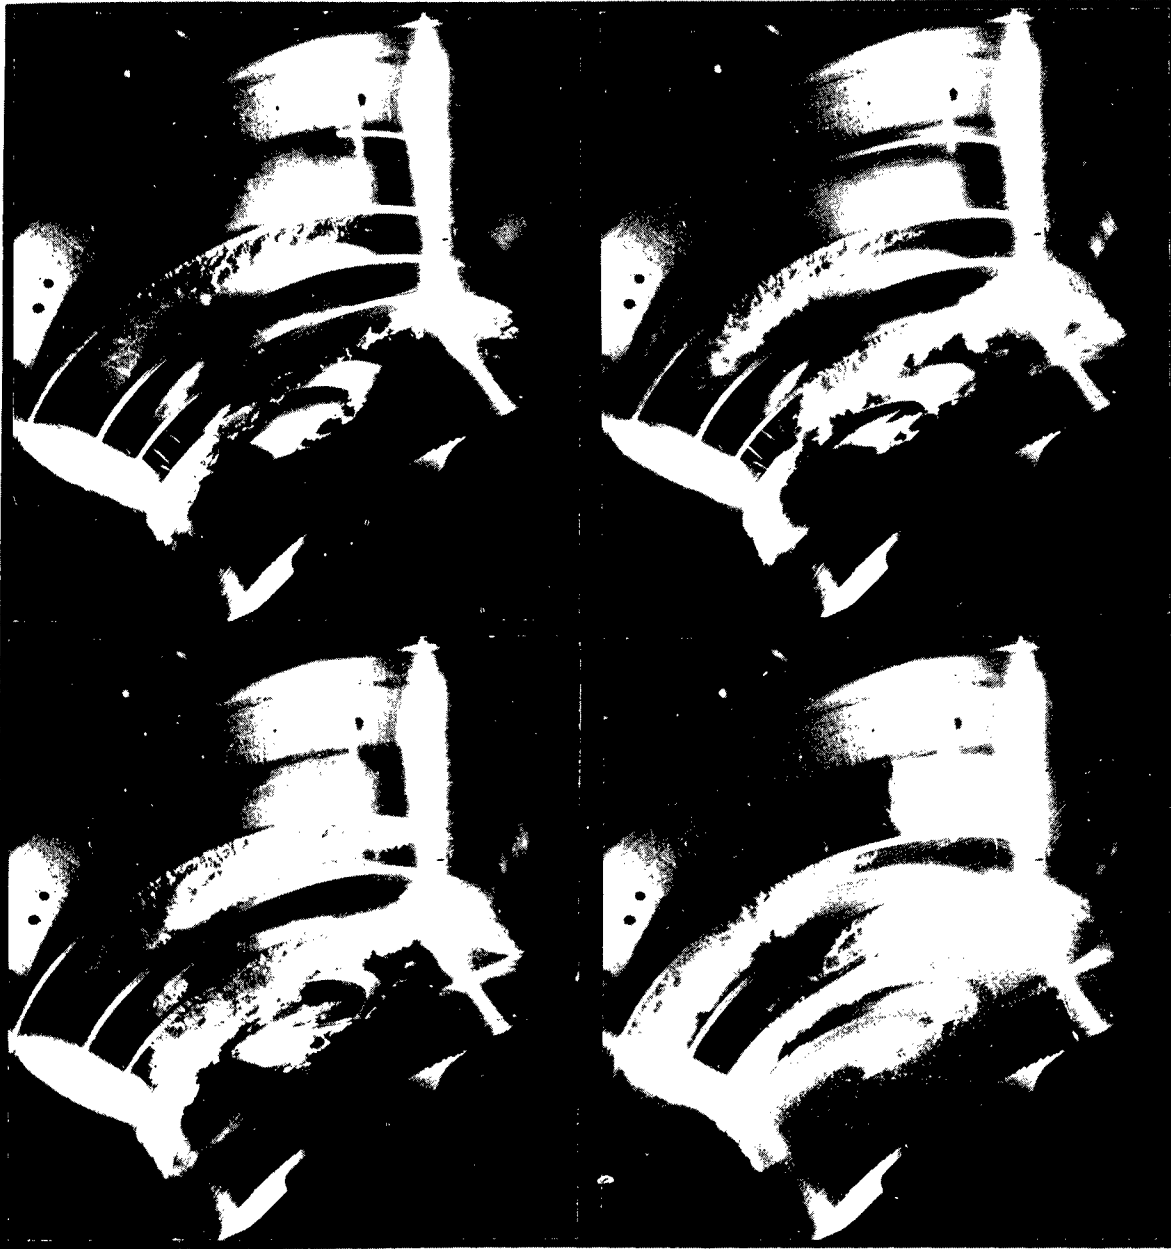
FIG 28

The cavitation pattern selected from the impeller water tests is shown in Fig. 28 corresponding to an NPSH of 17.7 feet and a suction specific speed of 19,500. At this condition, the cavitation bubble implosions in the rear channels of the impeller did not appear to collapse on the vane surfaces. Although bubble implosions were observed to occur on the vane surfaces near the leading edge, they were not judged to be as potentially damaging as cavitation implosions occurring in the rear channel regions where high pressure gradients existed. Also, since no evidence of cavitation pitting attack was found after several hundred hours of accumulated water testing in cavitation, it was decided to test the impeller in potassium at this high value of suction specific speed. A correction of 1.1 feet of NPSH was introduced on the basis of the thermal cavitation criterion derived by Stepanoff (Ref. 11), which accounts for the differing thermal properties of cold water and 1400F potassium as related to cavitation bubble formation. Therefore, the NPSH of 17.7 feet for the water test was adjusted to an NPSH of 16.6 feet for the potassium test to produce an equivalent cavitation pattern in the impeller for both tests. This corresponded to a suction specific speed of about 20,000 for the endurance test with 1400F potassium.

NPSH=17.7 FT
 $N_{SV}=19,500$

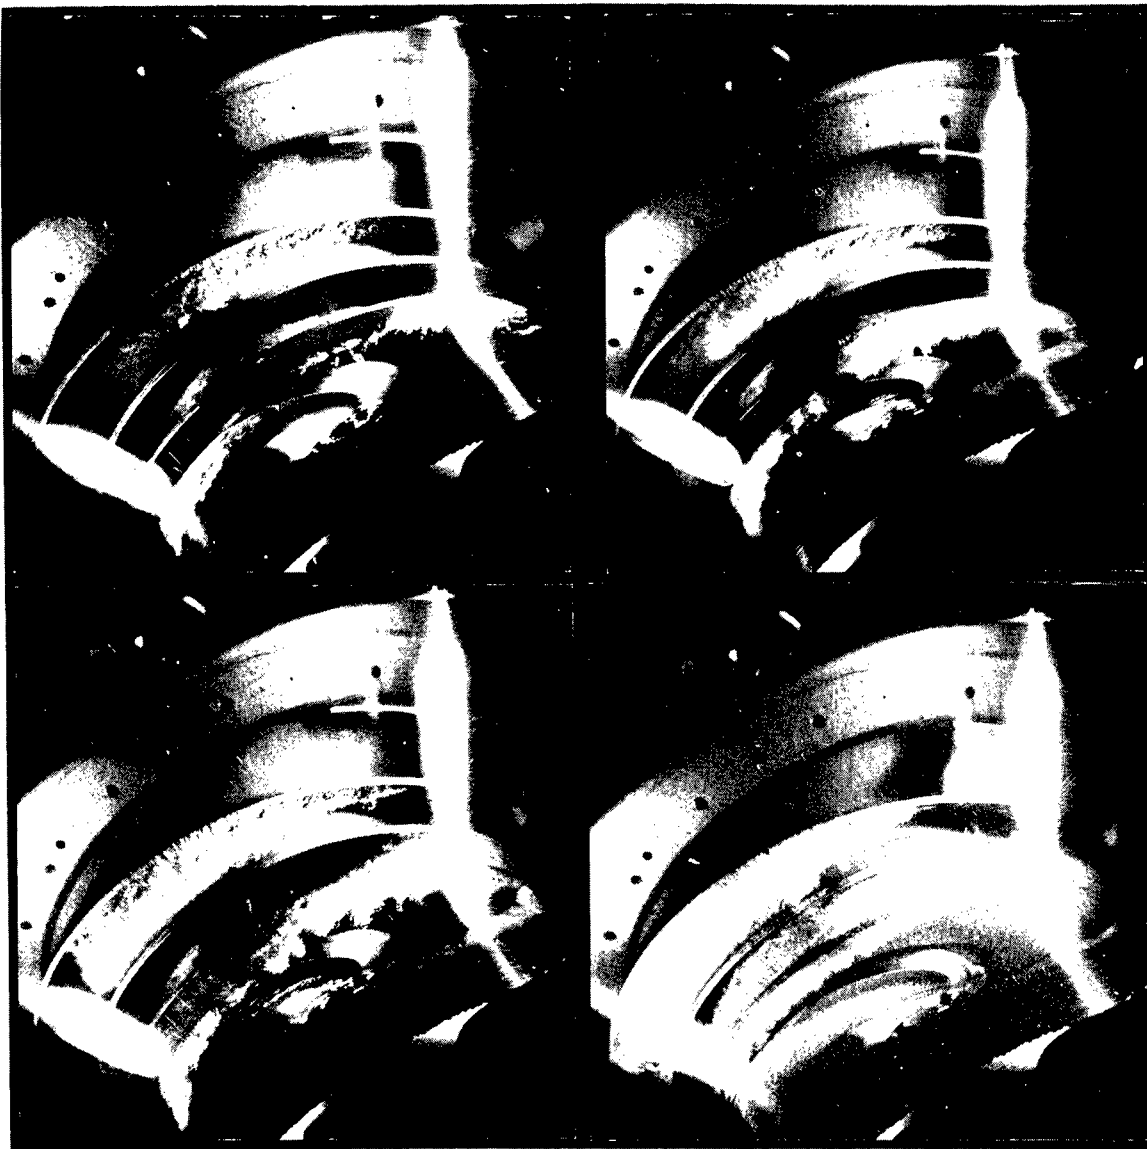
The flow rate of 700 gpm was tentatively selected for the liquid metal test based on direct observations of the cavitating impeller and the still photographs. The reason for this choice can be seen by noting the following things from Figs. 24, 27, 29 and 30. In Fig. 24, the 700 gpm flow appears to reach the lowest value of NPSH of all flows run before performance begins to fall off. The inlet cavitation cloud seen in Fig. 27 appeared cyclic, reaching well into the impeller passages at times. This effect can be seen in the photograph for NPSH of 19 feet. The photographic procedure utilized two strobe lights for illumination which were synchronized and operating at a lower harmonic of the shaft speed to maintain light intensity. The 35 mm camera and film used to take the pictures required a shutter speed which allowed two to four flashes of the strobe light to occur while the shutter was open. The cyclic action of the cavitation cloud is, therefore, less well lighted in the photograph than is the steady formation. This cyclic action is not apparent at 700 gpm (Fig. 28, 17.7 NPSH). Further, the rear channel cavitation at 700 gpm and 17.7 feet NPSH does not appear to be as intense as that for 720 gpm and 21 feet NPSH (Fig. 29).

NPSH - 21 FT
 N_{SV} - 17,420

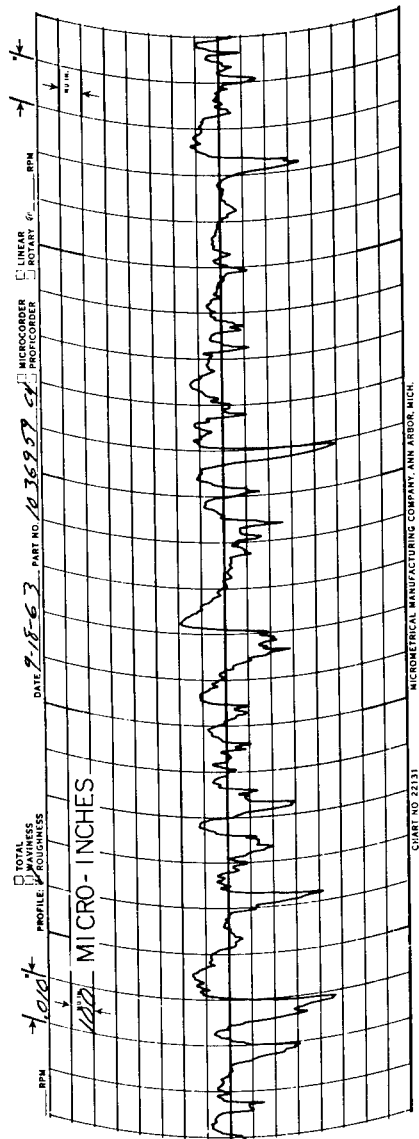
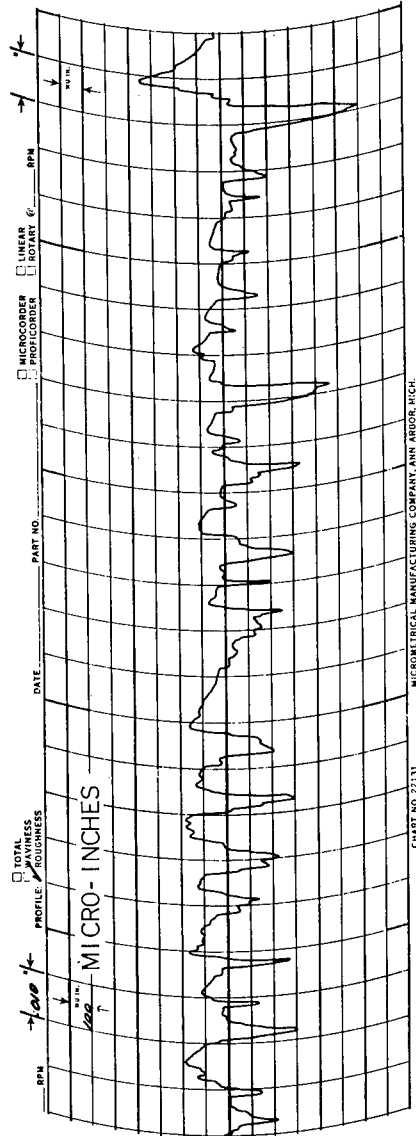
SURFACE ROUGHNESS MEASUREMENTS COMPARED AFTER WATER TEST BLADE 2, STATION 6, PRESSURE SIDE

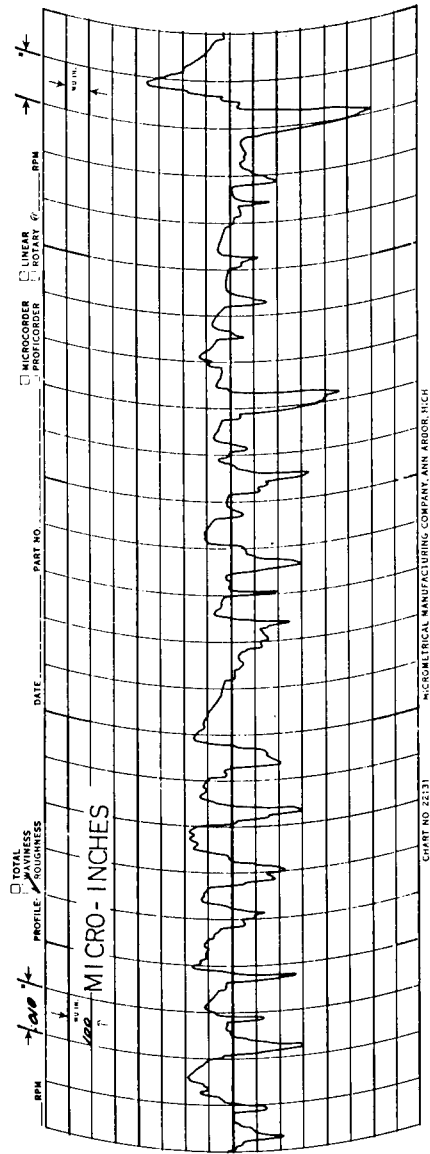
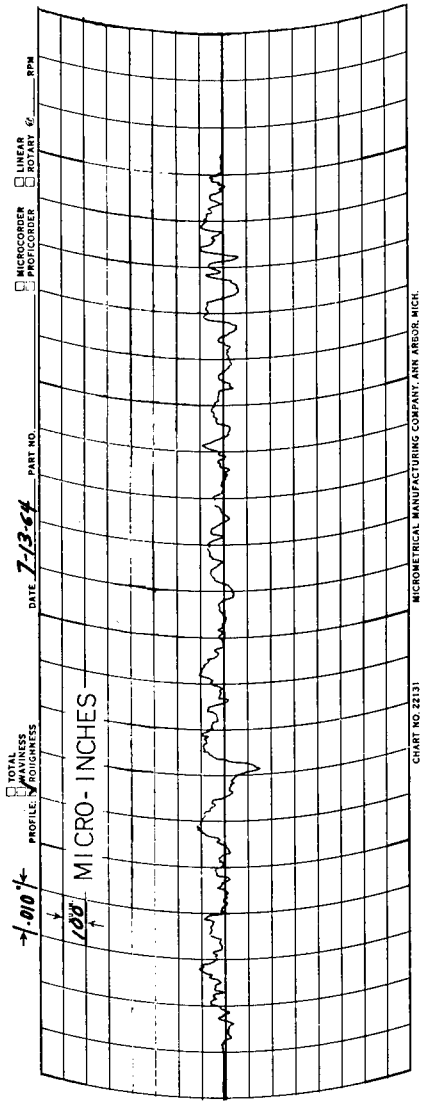
FIG 58

A complete program of inspection was performed on the impeller using all techniques previously noted. The surface roughness measurements made along the same vane stations as those in pretest indicated a slight smoothening of the surface had occurred. This can be seen in the surface roughness traces shown in Fig. 58. This smoothening action was apparently caused by a slight erosive action of the liquid metal.

SURFACE ROUGHNESS MEASUREMENTS COMPARED AFTER LIQUID METAL TEST BLADE 2, STATION 6, PRESSURE SIDE
